Coastal Inlets Research Program

**Shinnecock Inlet, New York,
Site Investigation**

**Report 1
Morphology and Historical Behavior**

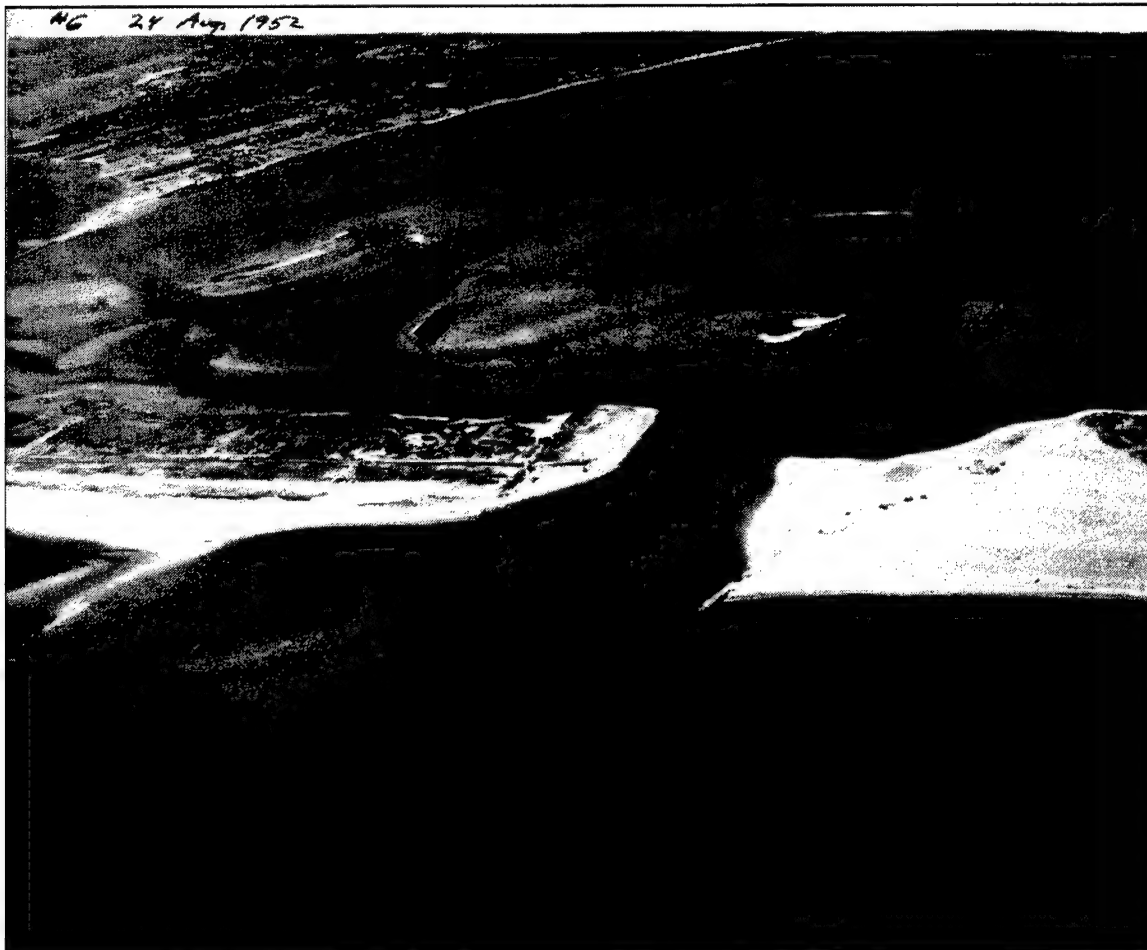
Figure 10. Photograph taken during construction of east jetty, 24 August 1952 (Channel runs northeast-southwest, closely following revetment on west shoreline and heads out to sea just east of a spit on Tiana Beach. Ebb shoal has an almost straight seaward margin. On flood shoal, three channels merge at bay end of inlet. Two of these channels, east and central, have shoaled) (Westhampton Photo Studio, from Suffolk County Department of Public Works)

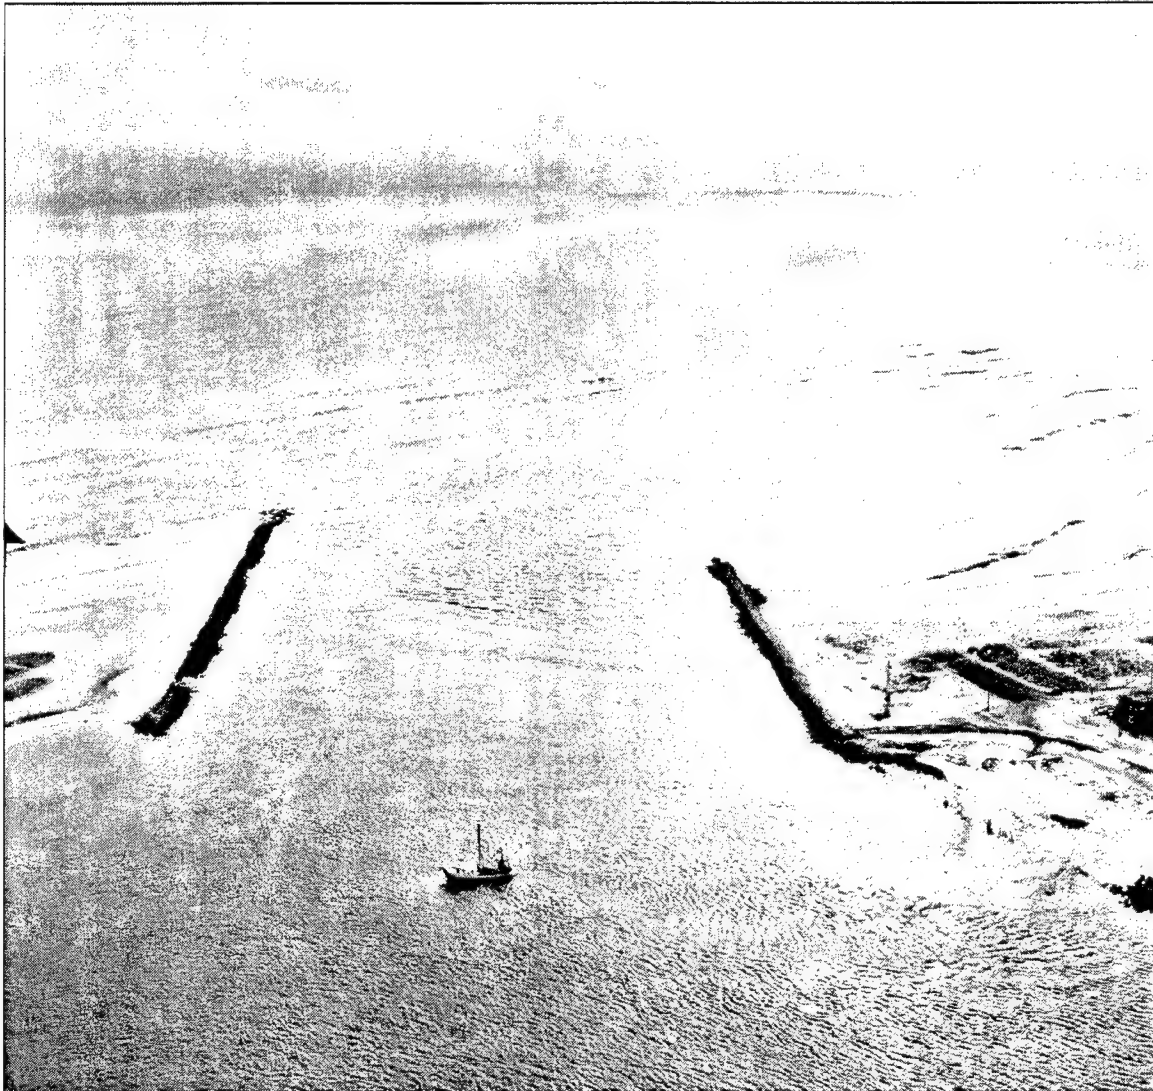
Figure 11. View south to Atlantic Ocean, 18 January 1980 (Waves can be seen bending over ebb shoal and concentrating on pocket west (to right) of west jetty. Note deterioration of both the east (left) and west jetties) (Topo-Metrics image 08013 0-13)

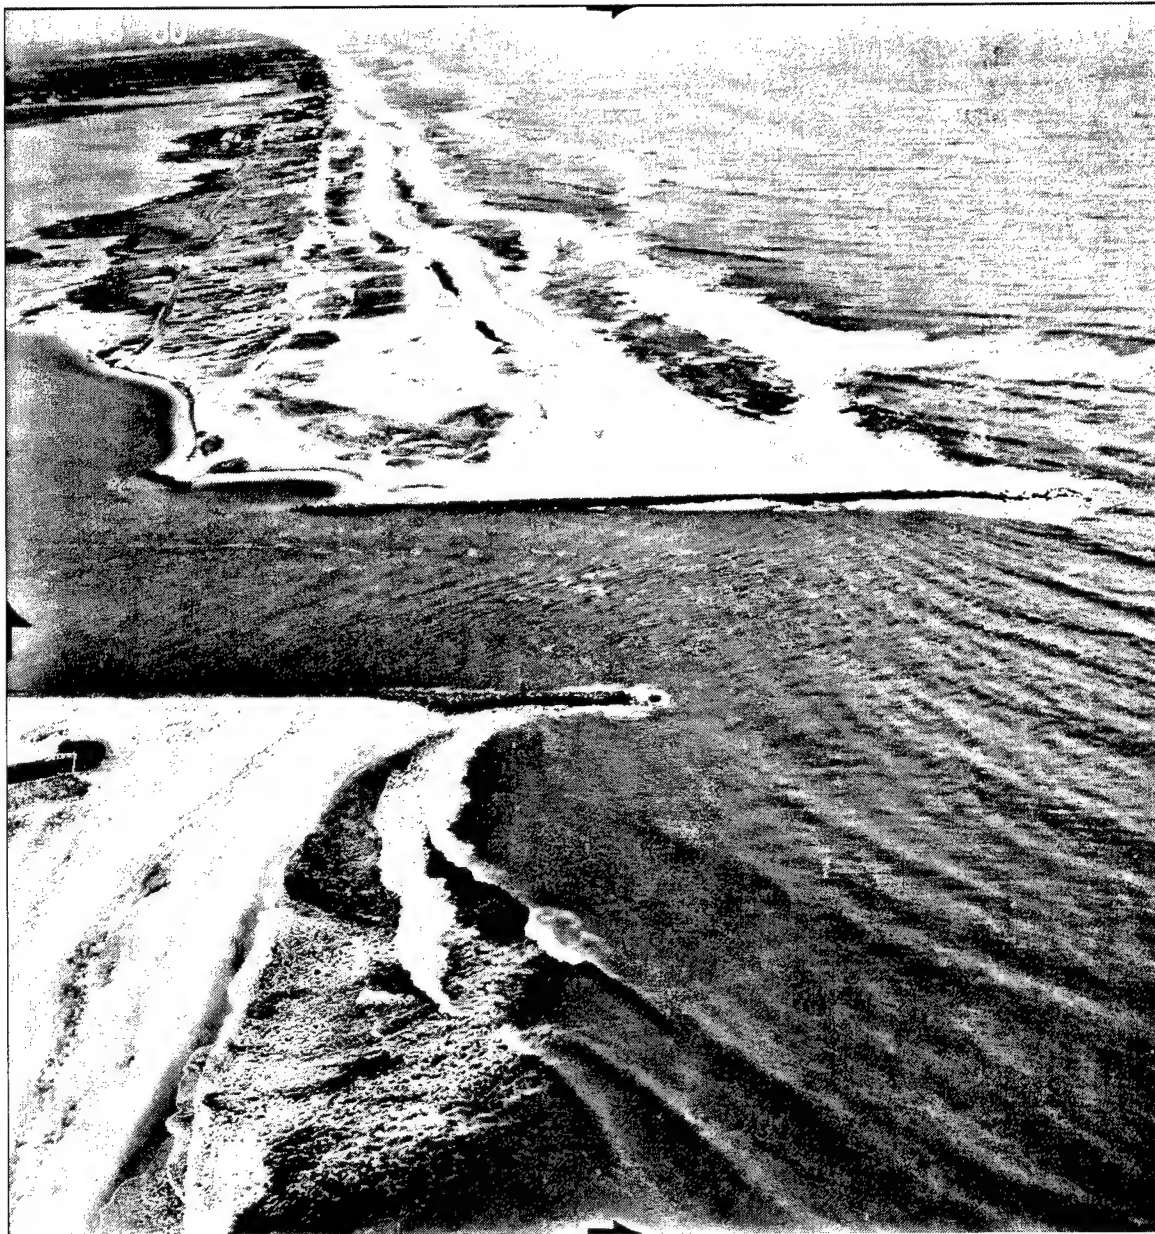
Figure 13. View east, with Atlantic Ocean to right, 18 January 1980 (Triangular-shaped updrift fillet is pronounced just beyond east jetty. Original, pre-inlet dune line approximately followed white line that marks dune crest in distance. Road paralleled dune crest and continued west before inlet was cut in 1938. Tip of west jetty has deteriorated. Remains of 1940 revetment are not visible in this image) (Topo-Metrics image 08013 0-16)

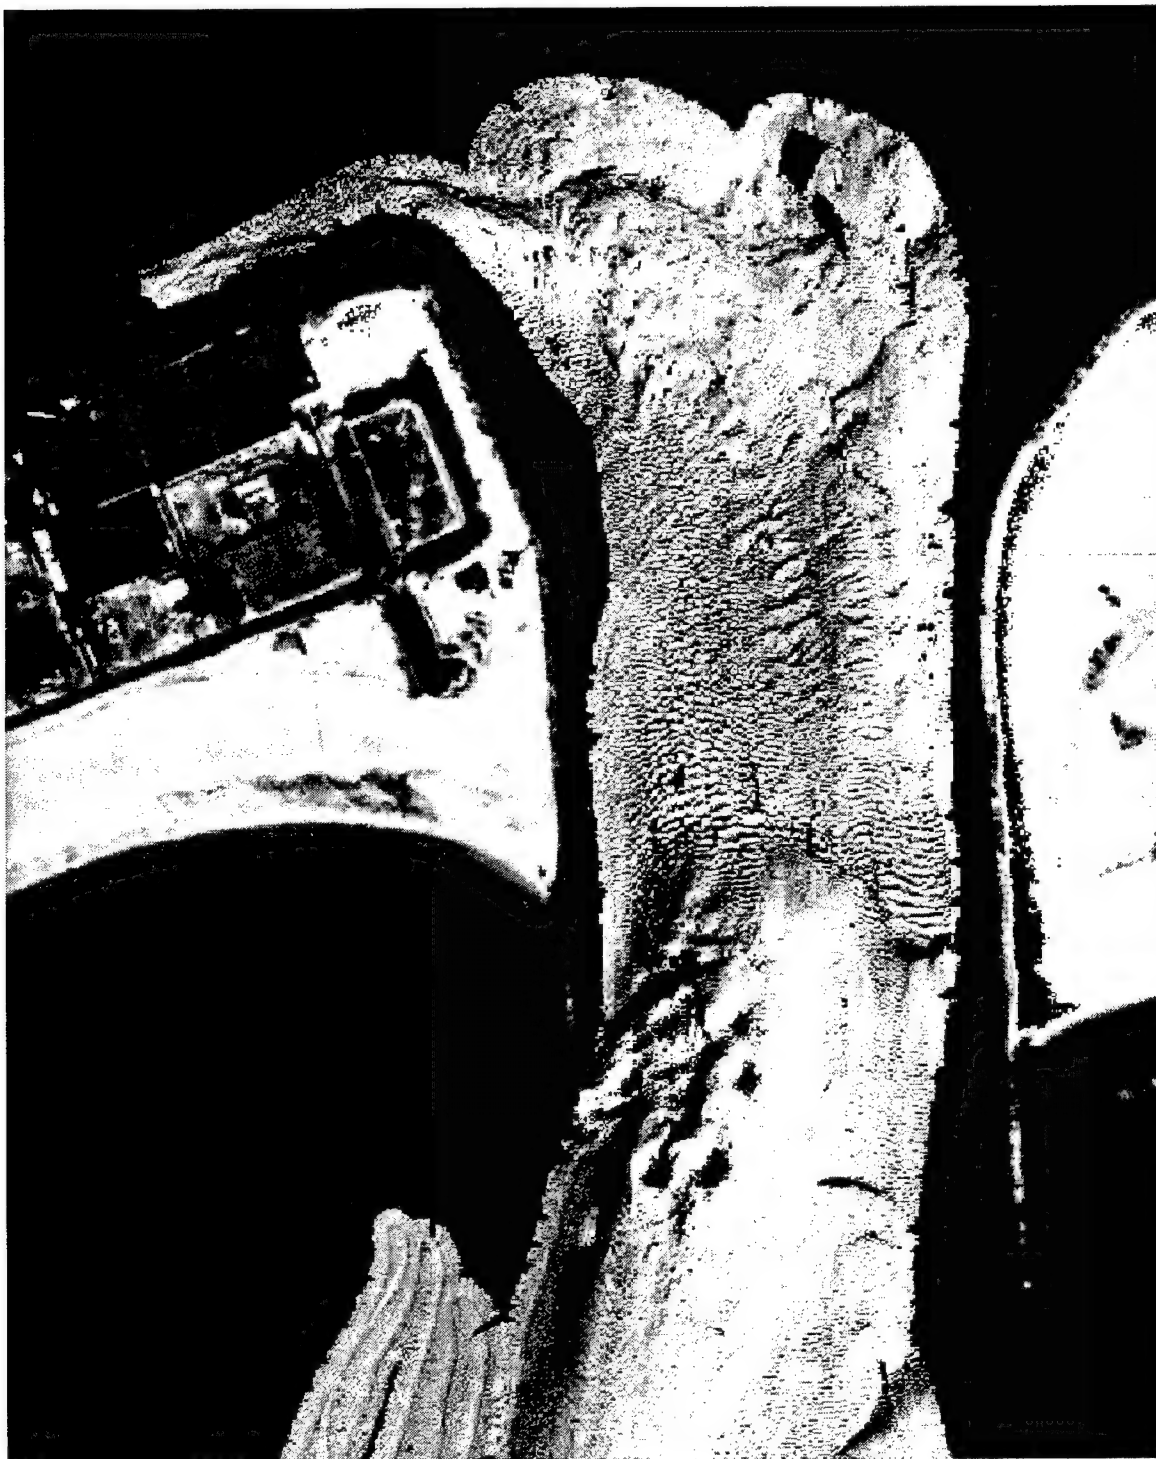
Figure 28. Multibeam acoustic data, 31 October 1998 (Sand waves are evident in inlet. Edge of sand ridge (discussed in text) is marked by line where the sand waves join featureless inlet floor. Highly irregular bottom near tip of west jetty indicates scour holes and remnants of scour blanket. Acoustic data processed at 1-m grid size, shaded with simulated sun position at 315° azimuth and elevation of 45°. Data collected and processed by Marine Sciences Research Center, State University of New York, Stony Brook, NY)

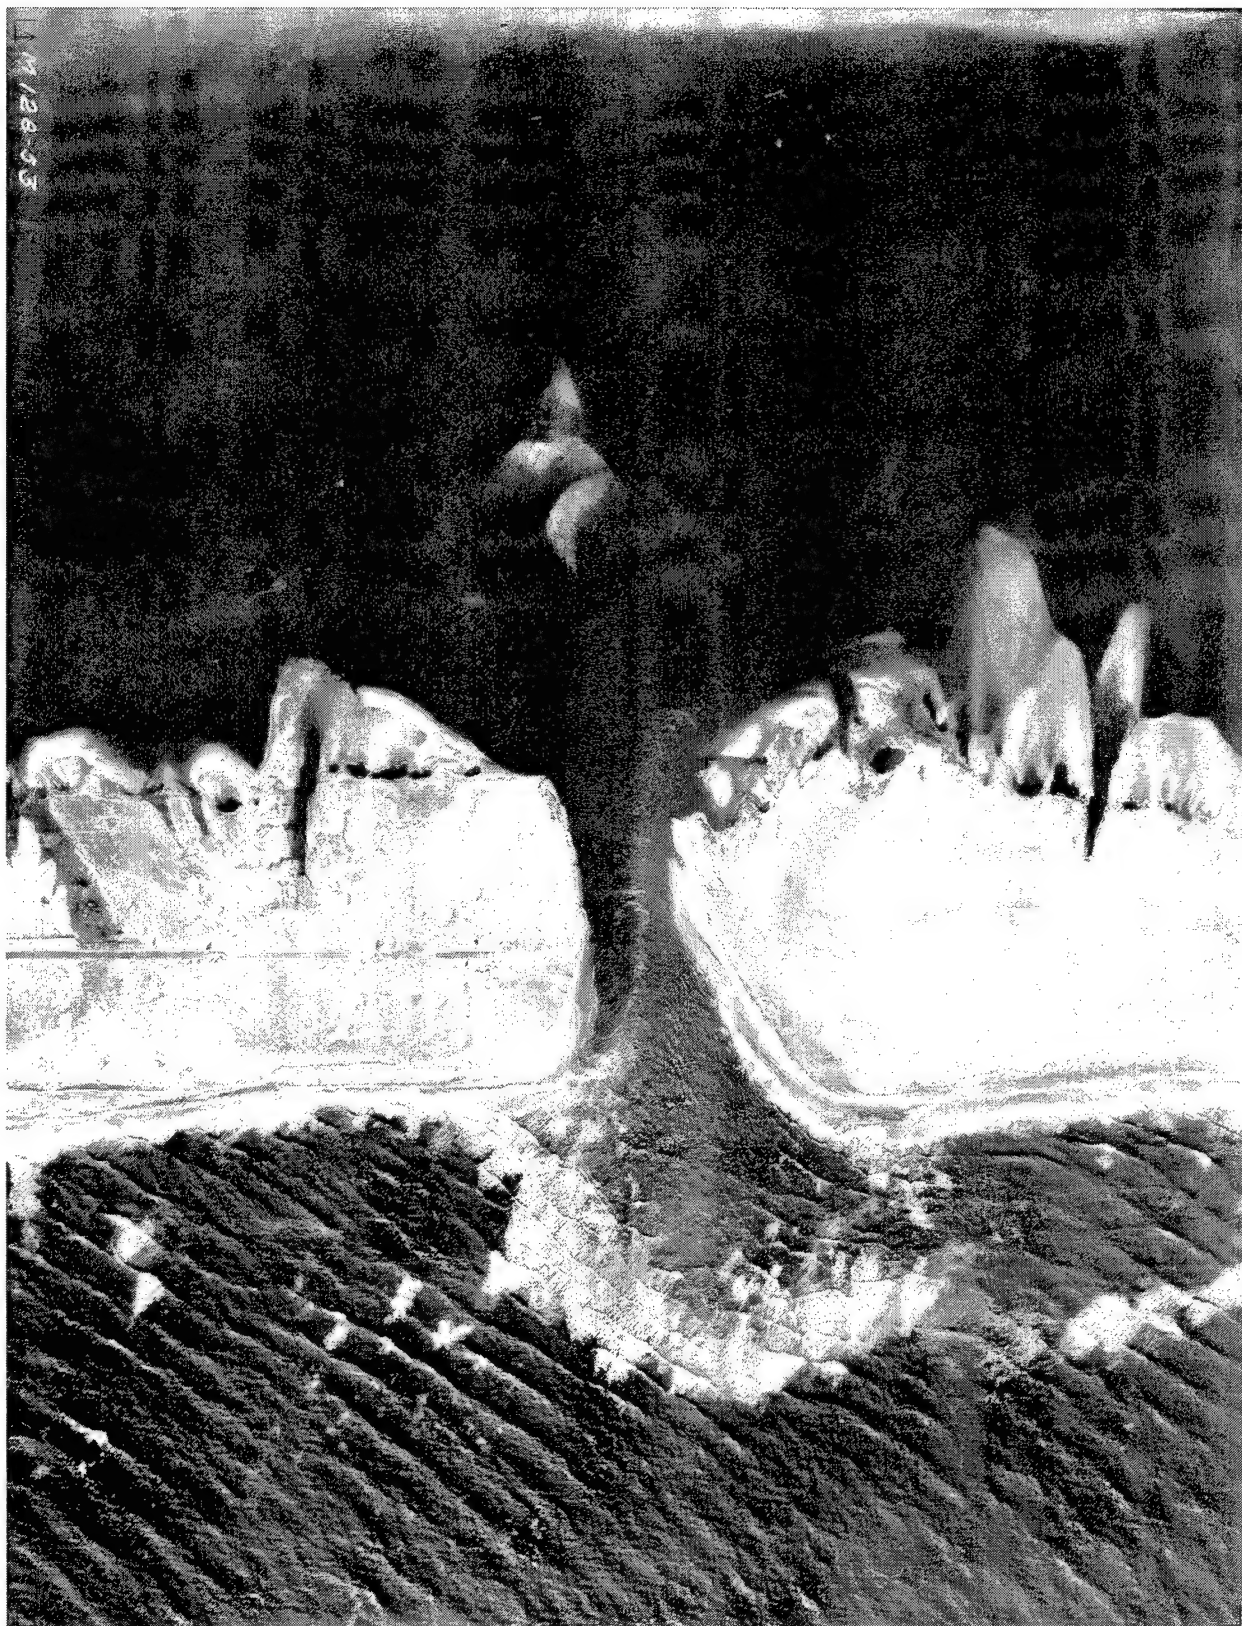
Figure A4. 29 November 1938 (Photograph two of three (centered on inlet). Ebb and flood shoals are already forming)

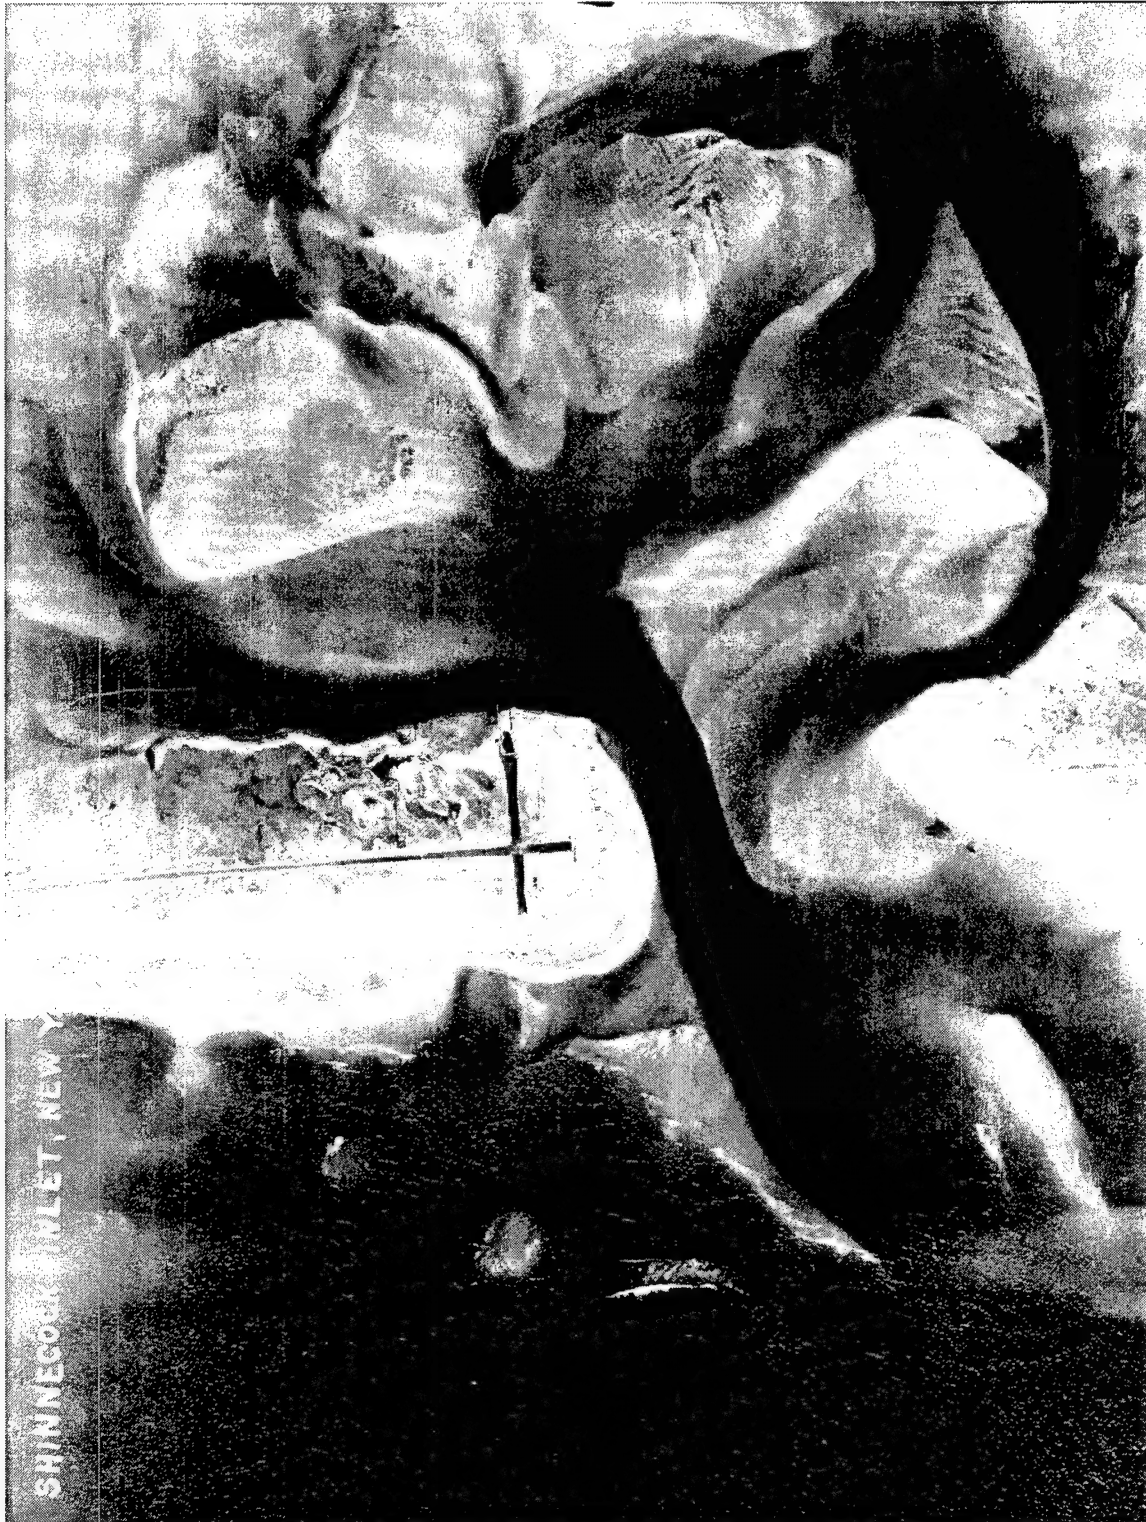
Figure A13. 1 April 1947 (Photograph one of two (inlet and west beach). Flood shoal has grown notably since 1941. Main channel through inlet has migrated away from west shore revetment and extends out to sea in a NW-SE direction. On flood shoal, east channel has shoaled next to east shoreline of inlet. Main channel now turns west and follows bay shoreline of west beach)

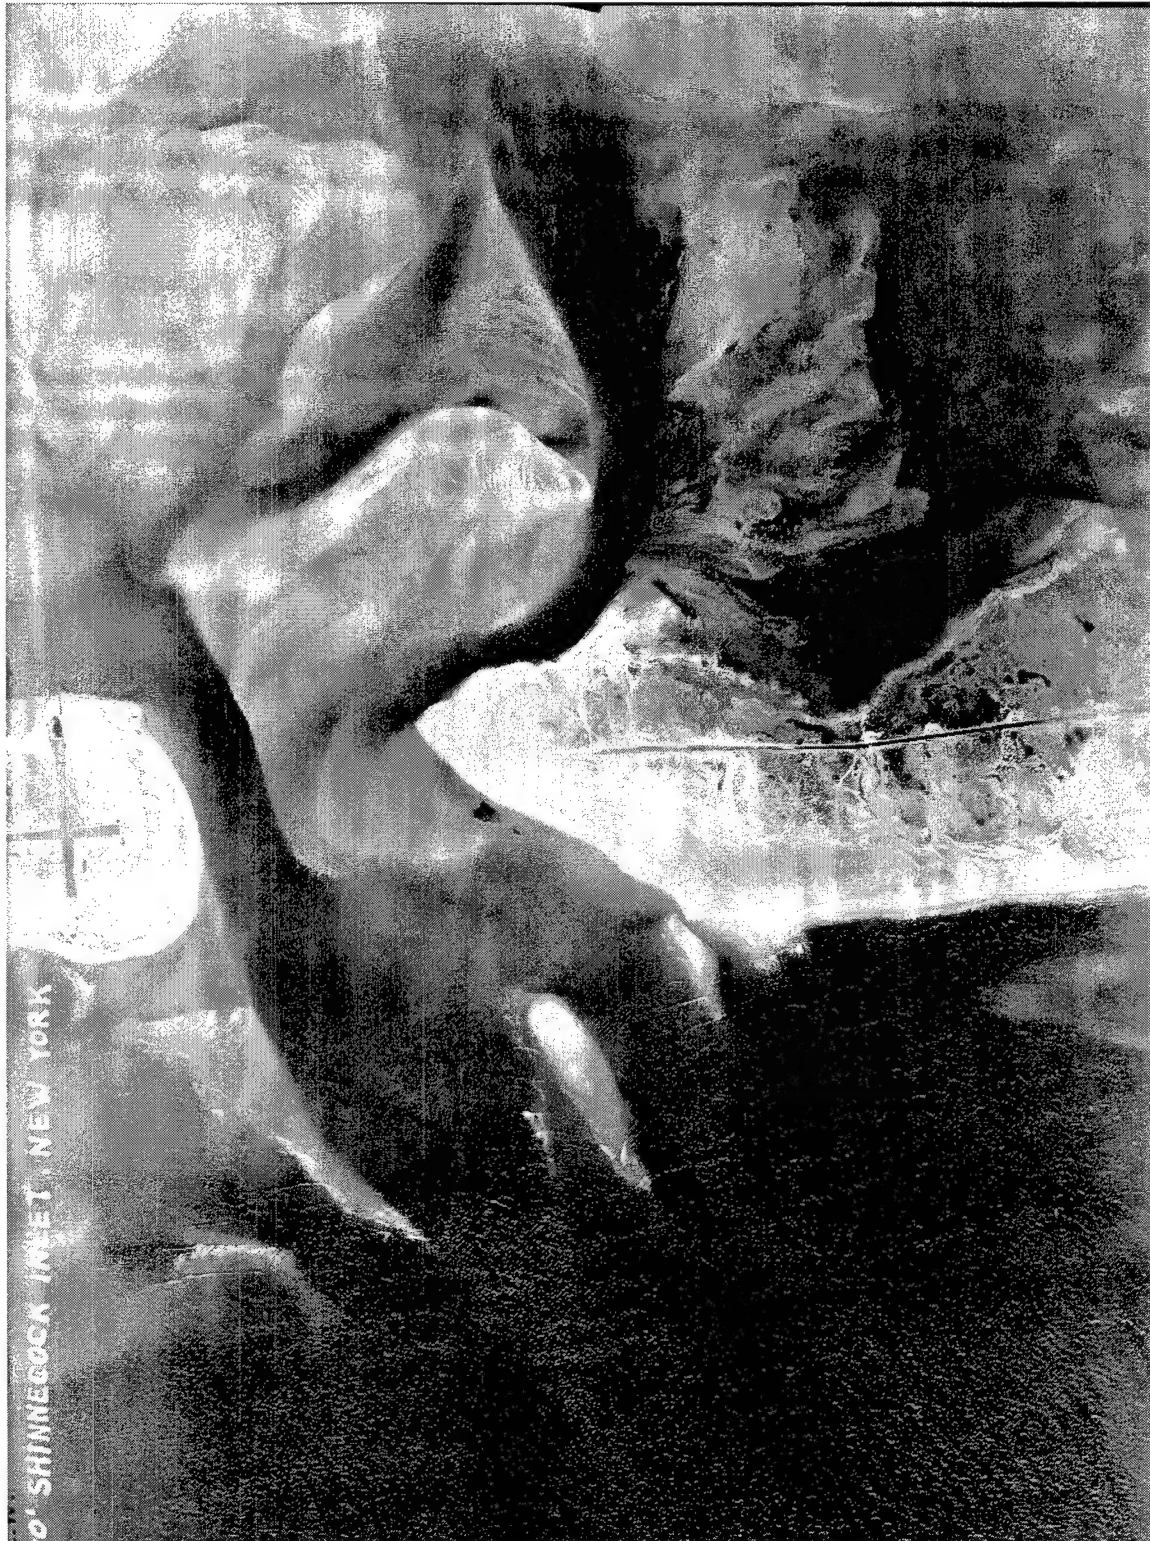
Figure A14. 1 April 1947 (Photograph two of two (inlet and east beach). Inlet's mouth contains two exposed sand shoals, and a spit has emerged from the west beach. Predominant longshore drift appears to have been west to east for a period before image was taken)

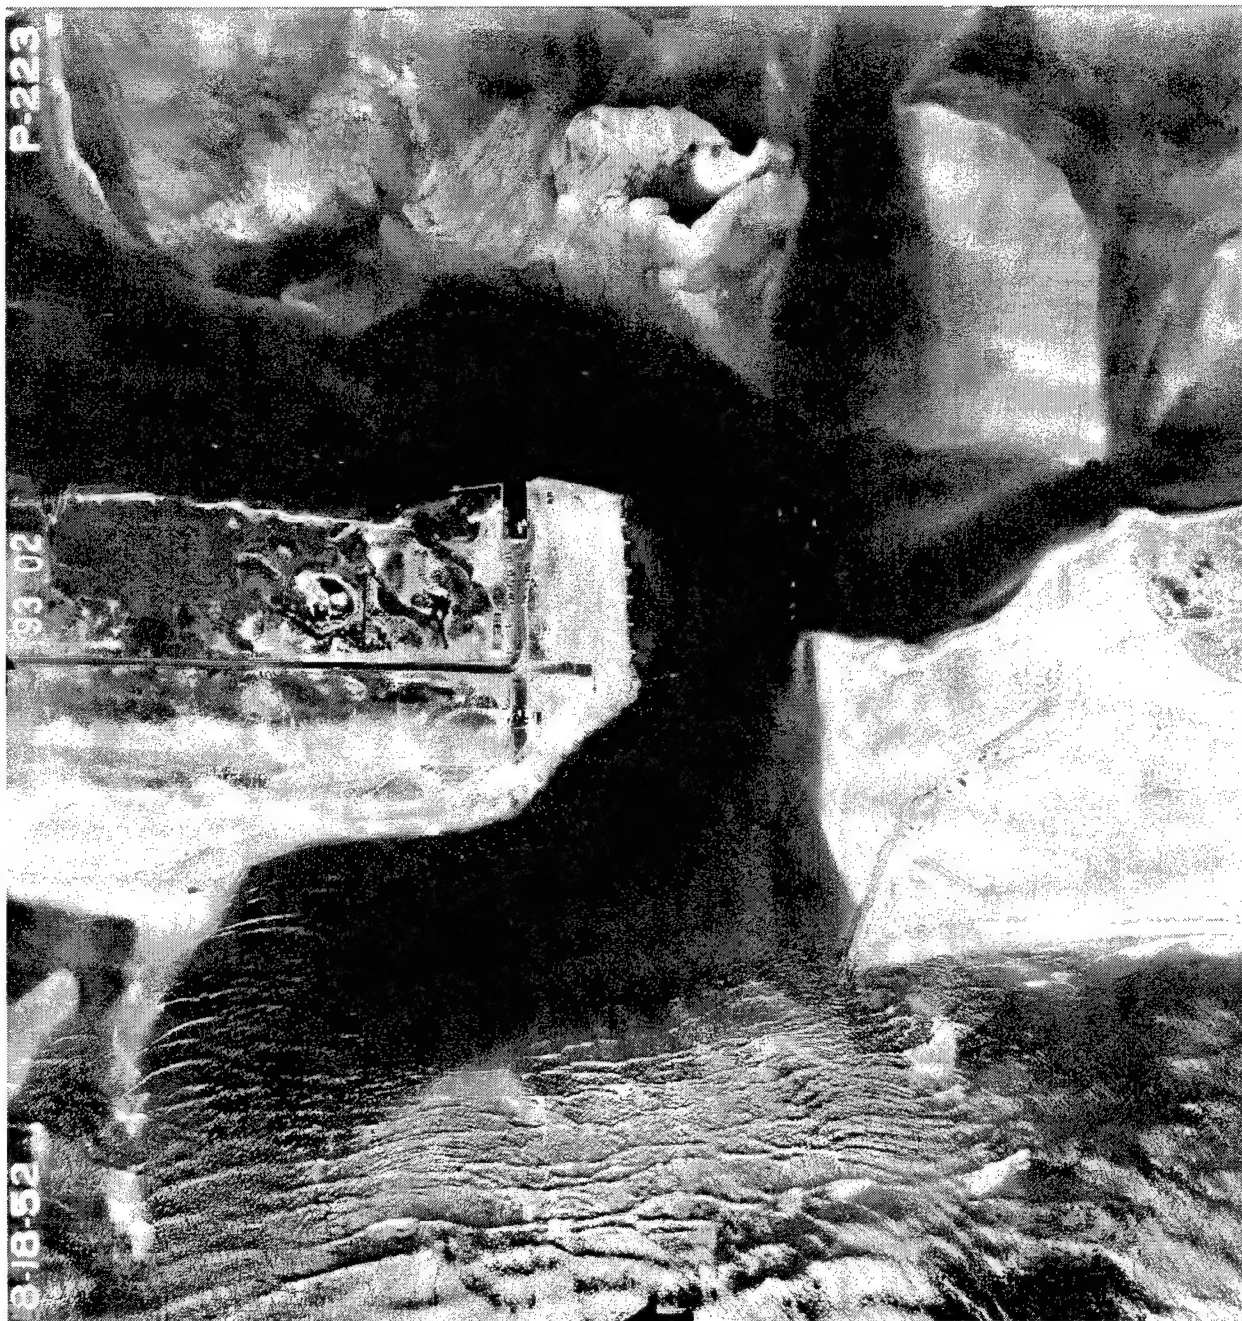
Figure A16. 18 August 1952 (Construction of east jetty is underway. North side of east beach has scoured, and a spit extends out to Atlantic from the west beach. This suggests that the main tidal currents ran approximately northeast-southwest)

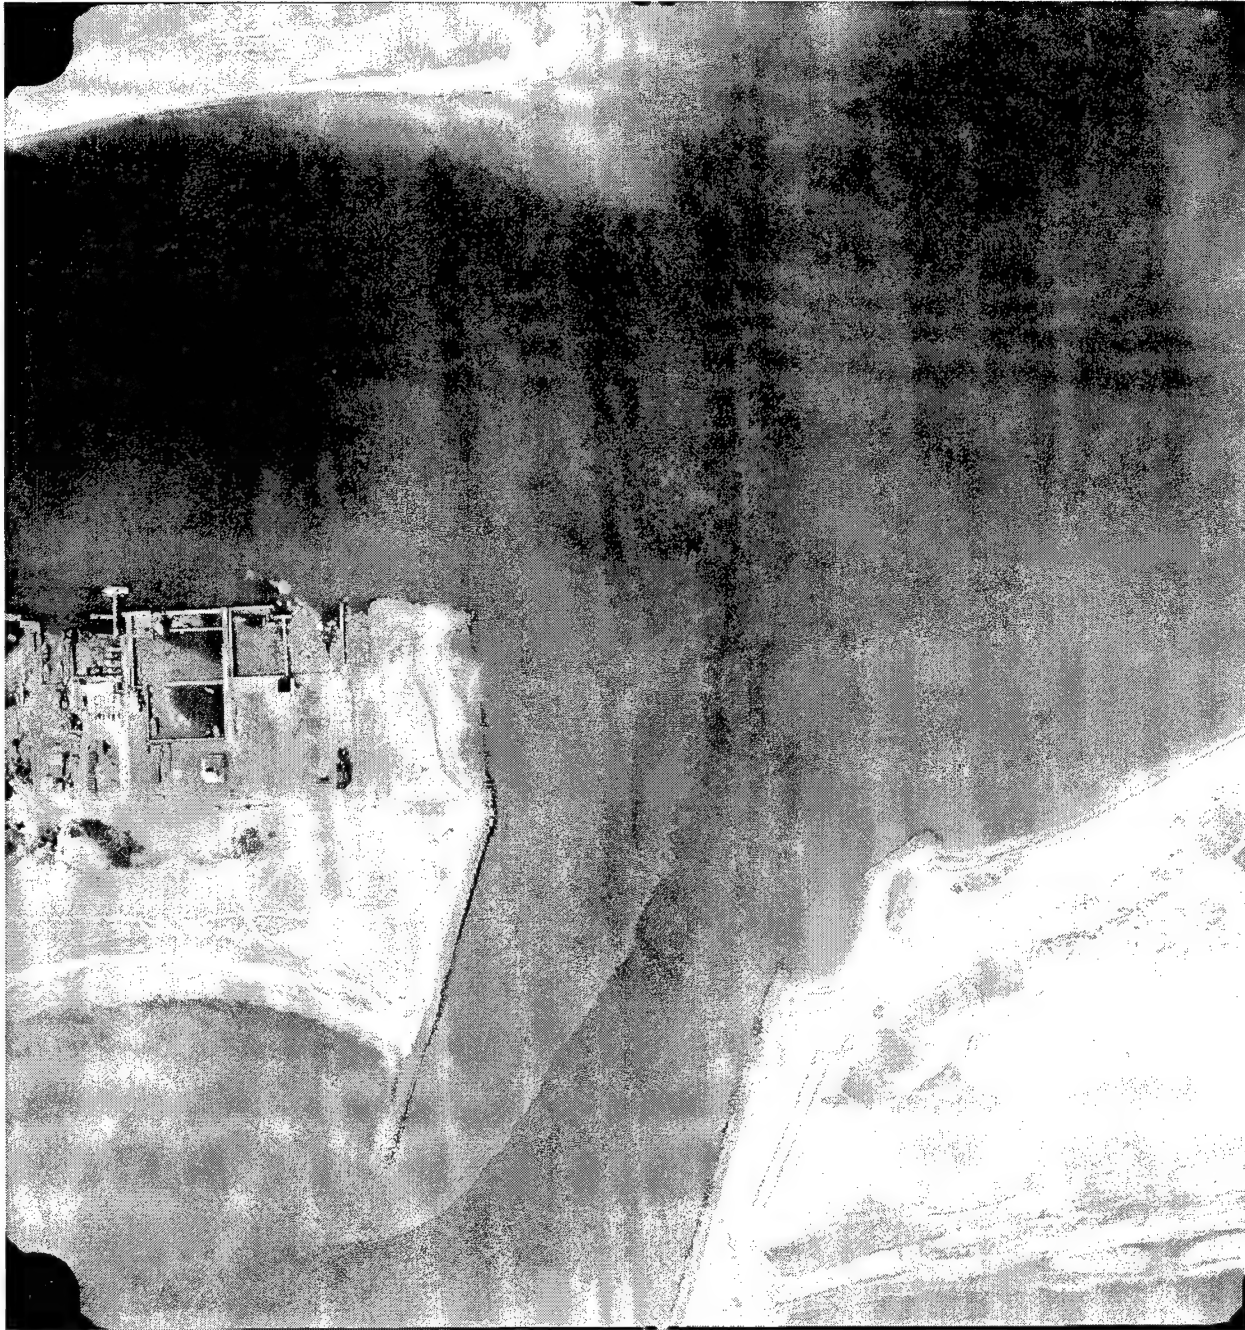
Figure A22. 23 February 1972 (Photograph, taken at lower altitude than previous images, shows damage to west and east jetties. Flood tide is entering inlet on east (right) side. A discontinuity marks where the flood tide entrains slack water. On west beach, dunes are vegetated as far east as cross road)

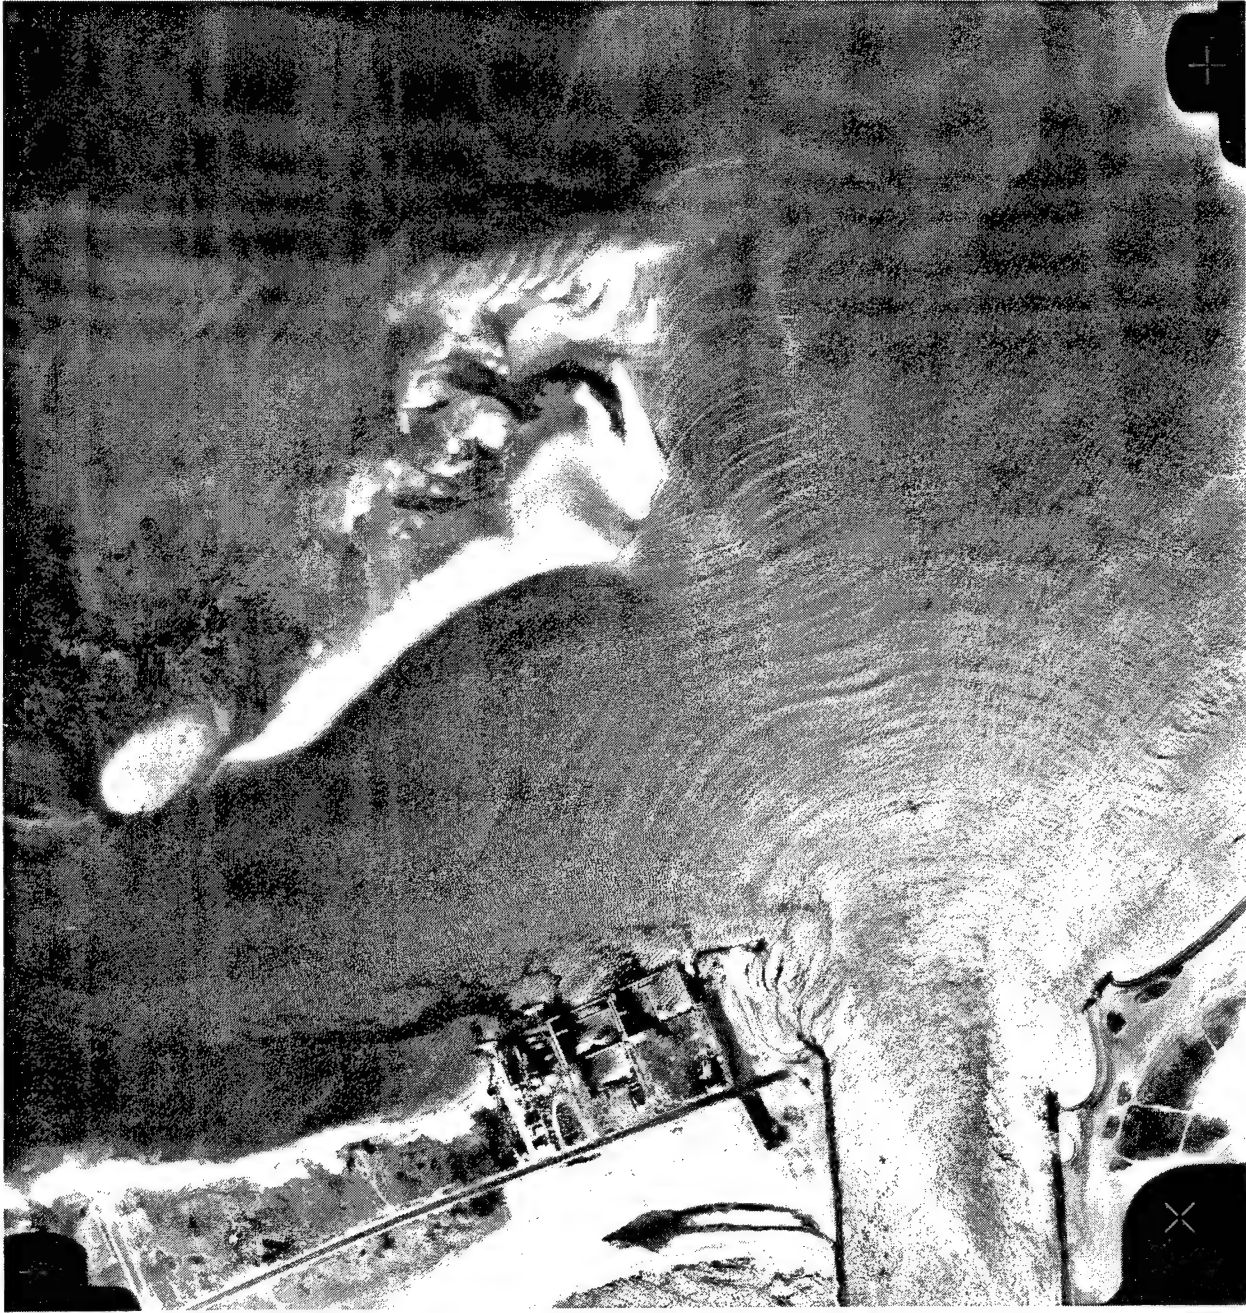
Figure A24. 6 April 1976 (Closeup view of north (bay) end of inlet. Sun glint reveals circular wave crests, a result of wave diffraction. Waves can be seen refracting into indentation in shore directly north of end of west jetty)

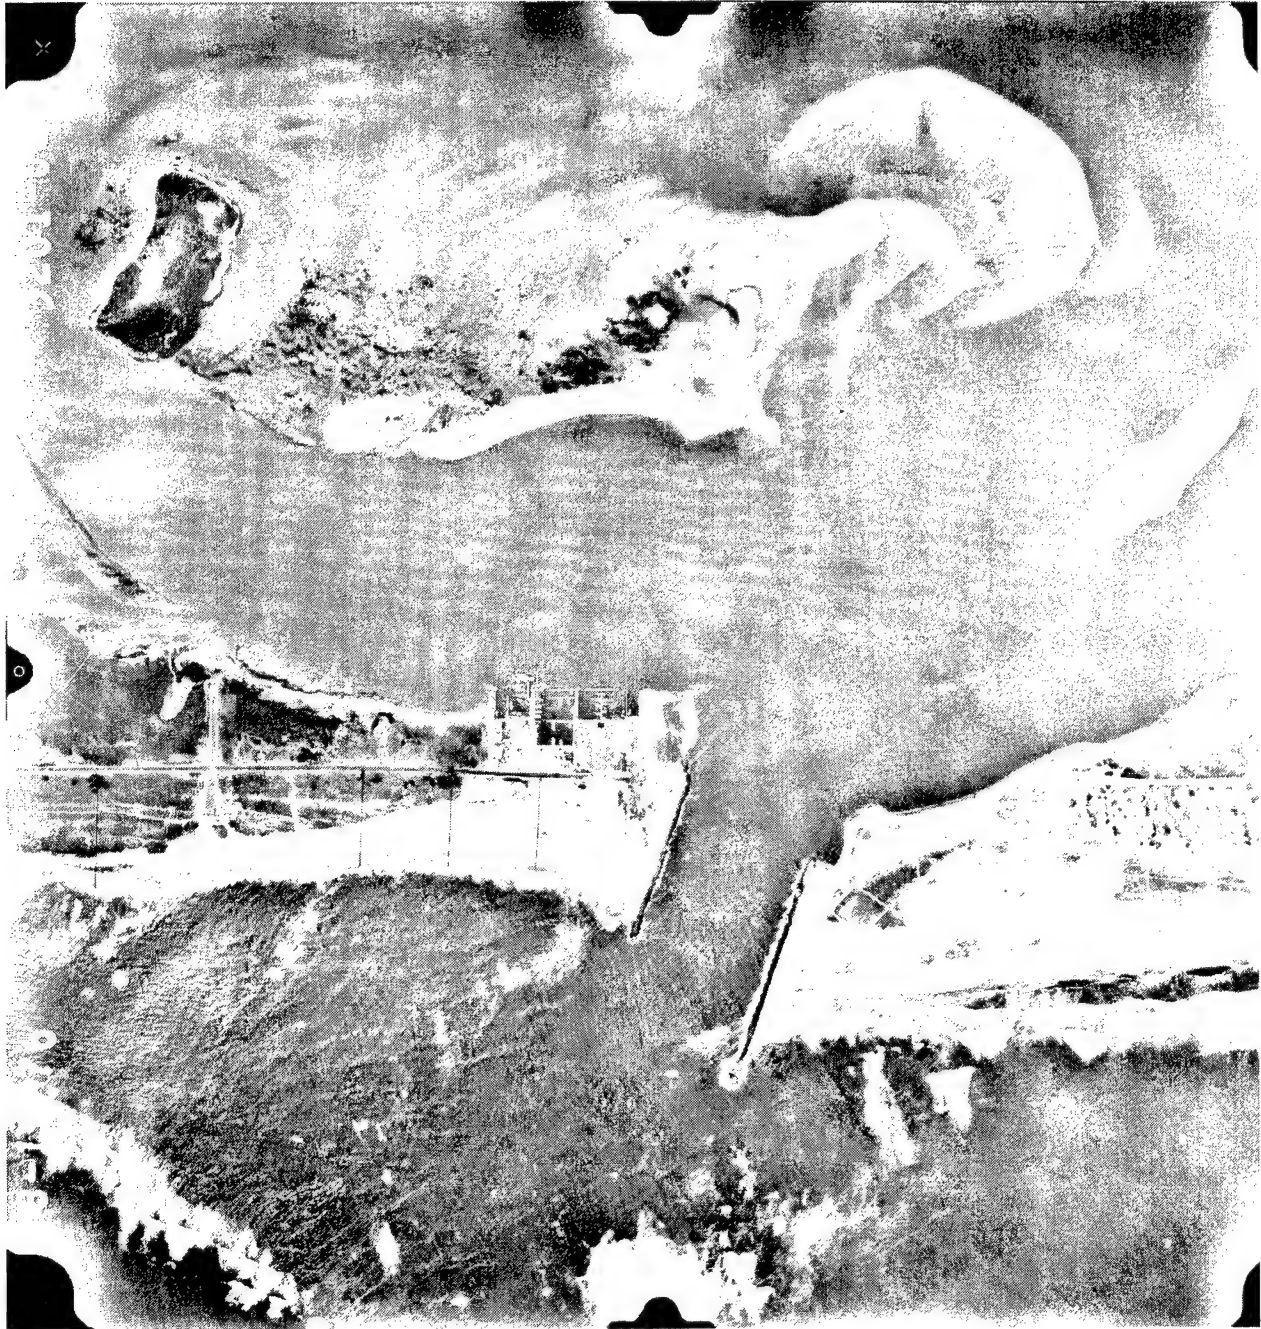
Figure A25. 10 August 1976 (Photograph was taken 1 day after Hurricane Belle crossed area. West beach is flush with end of west jetty. Only minor changes in flood shoal had occurred compared with April image. Compared with 1962, ebb shoal had grown and seaward edge moved further offshore. Four black lines crossing west beach appear to be drawn with a pen on photographic paper print)

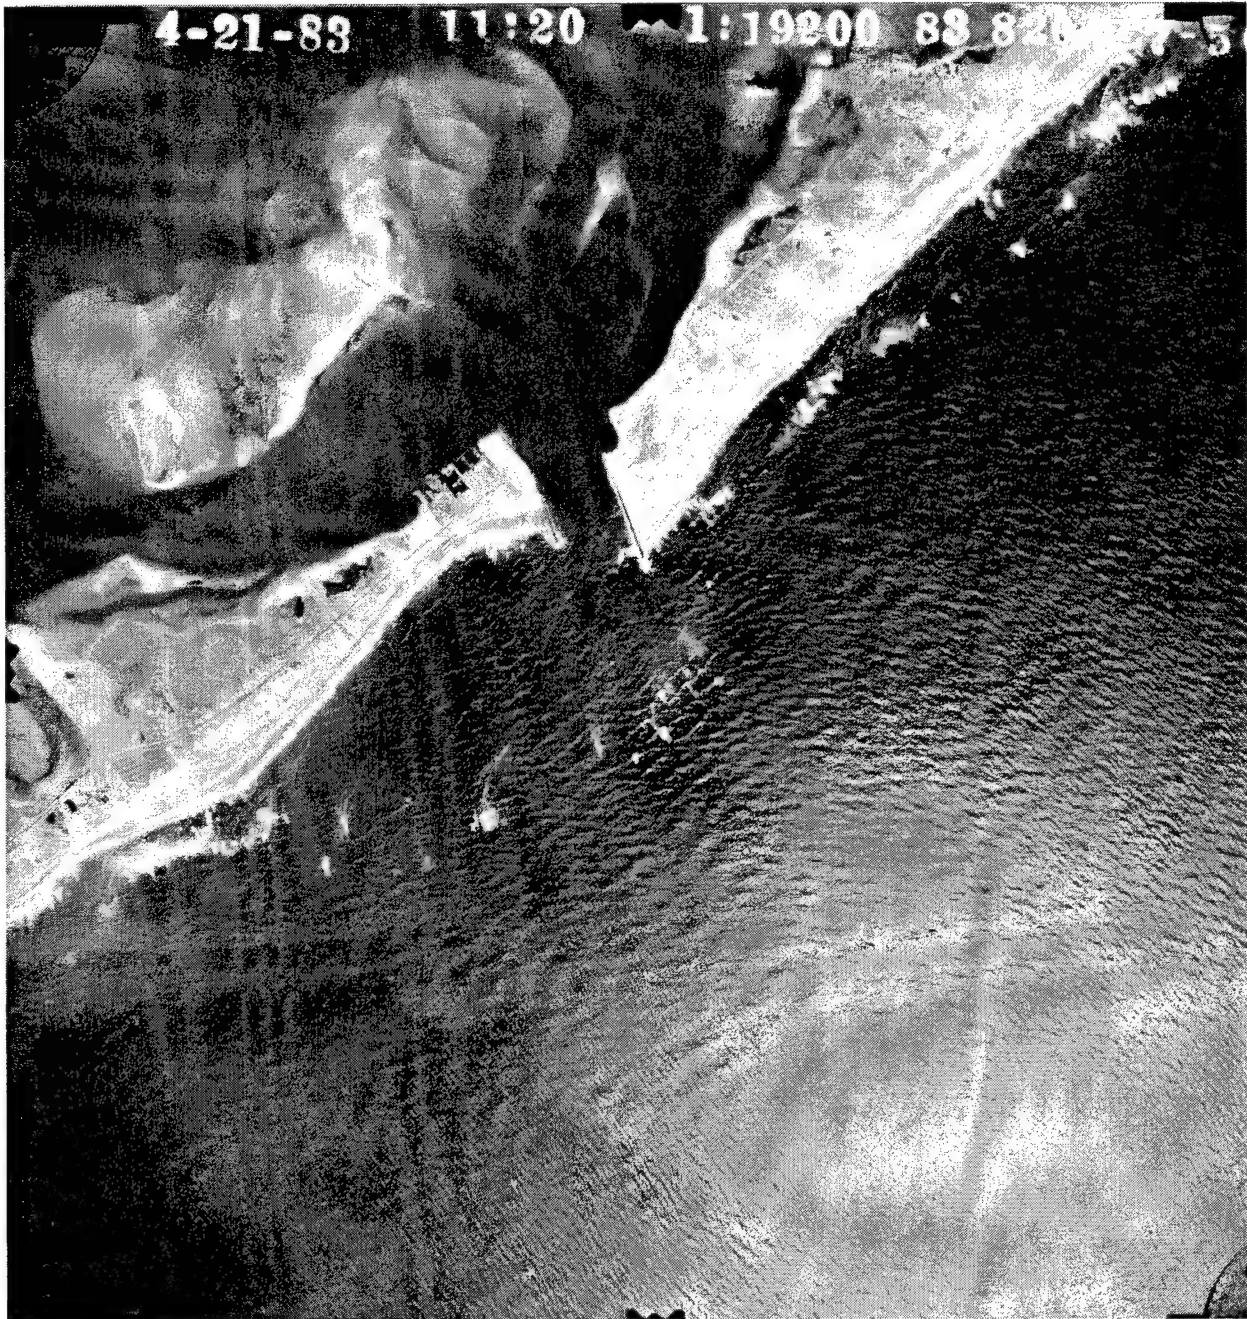
Figure A28. 21 April 1983 (Oval ebb shoal is outlined by breaking waves. The shoal attaches to downdrift (west) beach at the bulge in the shoreline. Bulge has moved about 500 m west compared with 1976)

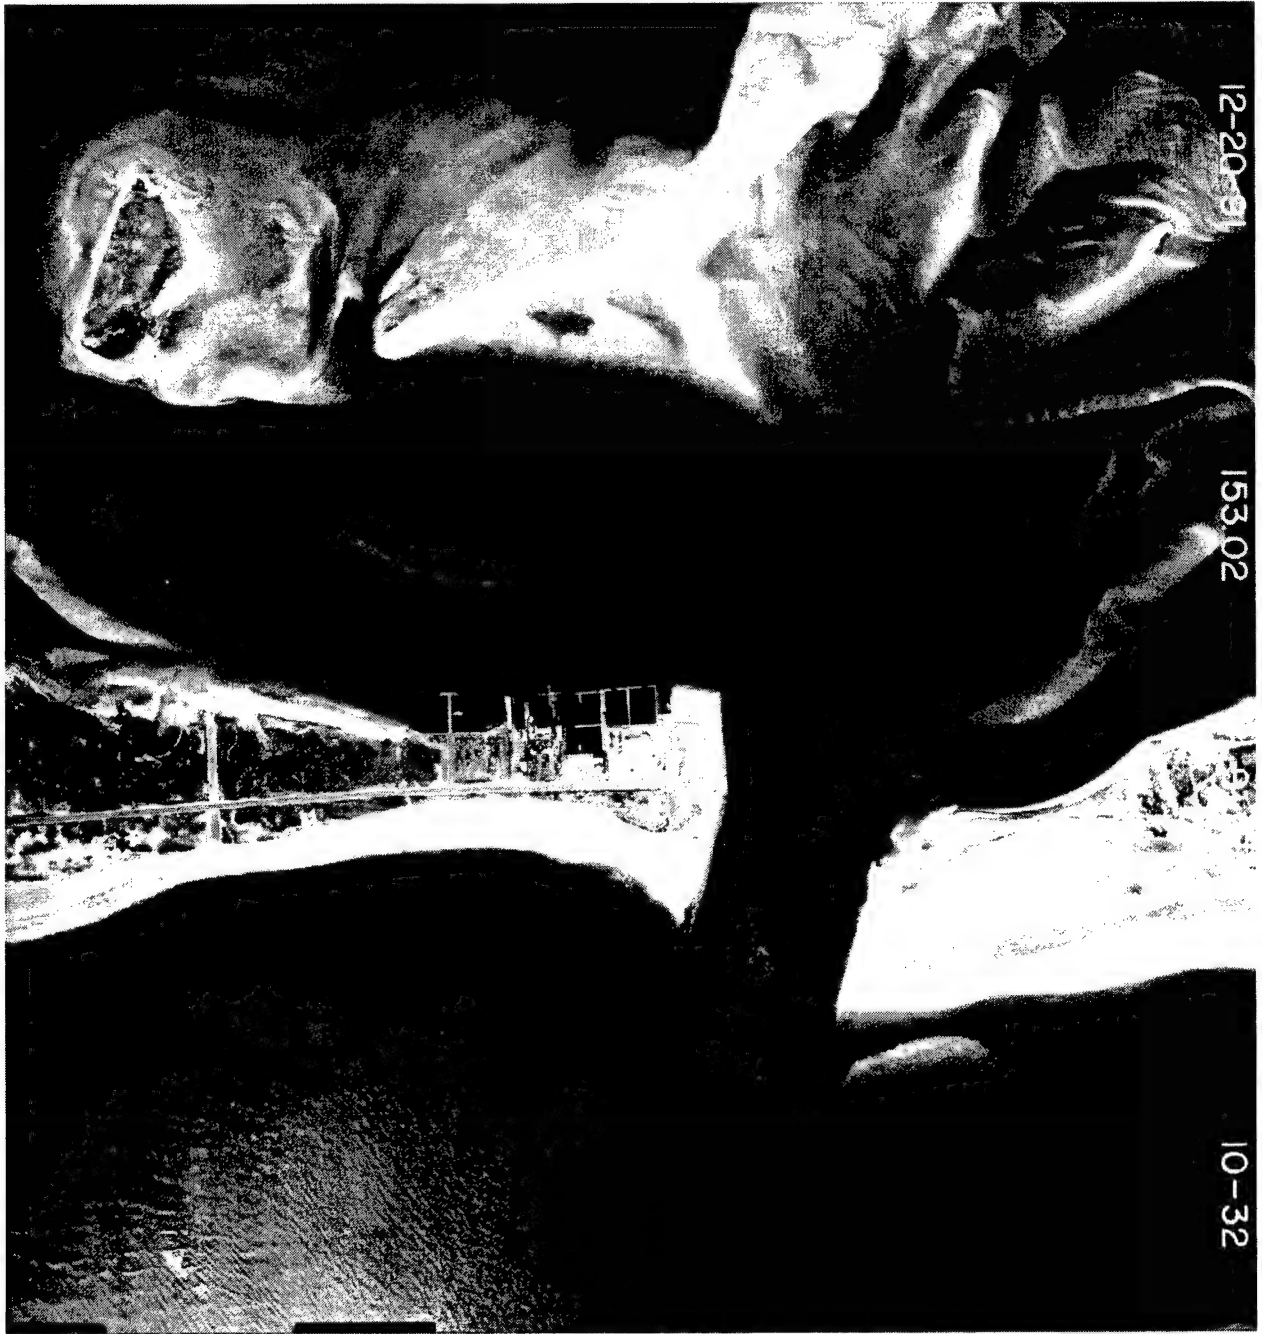
Figure A35. 20 December 1991 (Most features are unchanged from the previous figure, taken in September. Lack of change is surprising because the Halloween Northeaster of 30-31 October was reported to have caused erosion and damage along much of Long Island shore. Erosion pocket in east revetment has shoaled, and west beach has advanced about one-half of the distance to the jetty tip)
